Inspection Report

Minerals Regulatory Program

August 29, 2012

Mine Name: Cedar Springs	Permit Number: M/023/0059
Operator Name: Nephi Sandstone Corporation	Inspection Date: August 28, 2012
Inspector(s): Paul Baker	Time: 1:00 – 1:30 PM
Other Participants: none	Mine Status: INA
Weather Condition: 90 degrees and mostly clear skies	Last Inspection: August 9, 2012
Bond Renewal Date: 11/25/2008	Bond Amount: \$30,000.00
Surface Ownership: Fee	Mineral Ownership: Fee
Last Year of Production: 1999	Acreage: 6 acres

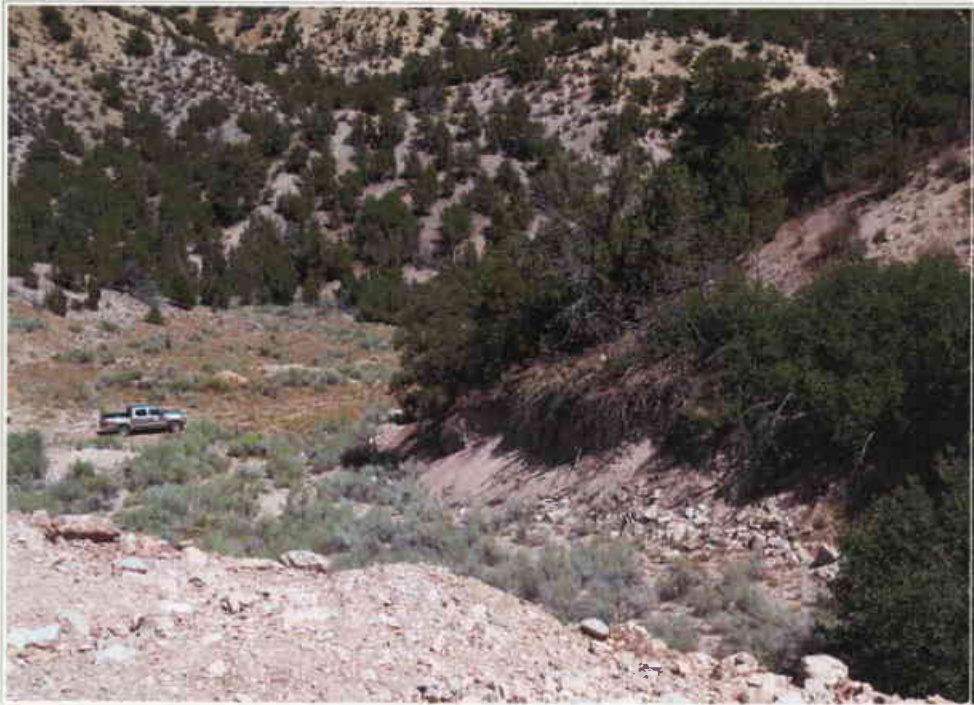
Paul Baker and Wayne Western inspected the site. The general conclusion was that most of the site met the minimum requirements for partial bond release with one area. To minimize erosion on slope should be pushed down. See photo for details.

Top of slope that should be pushed down.

The Operator should return in the fall to do minor earthwork and seedbed preparation.

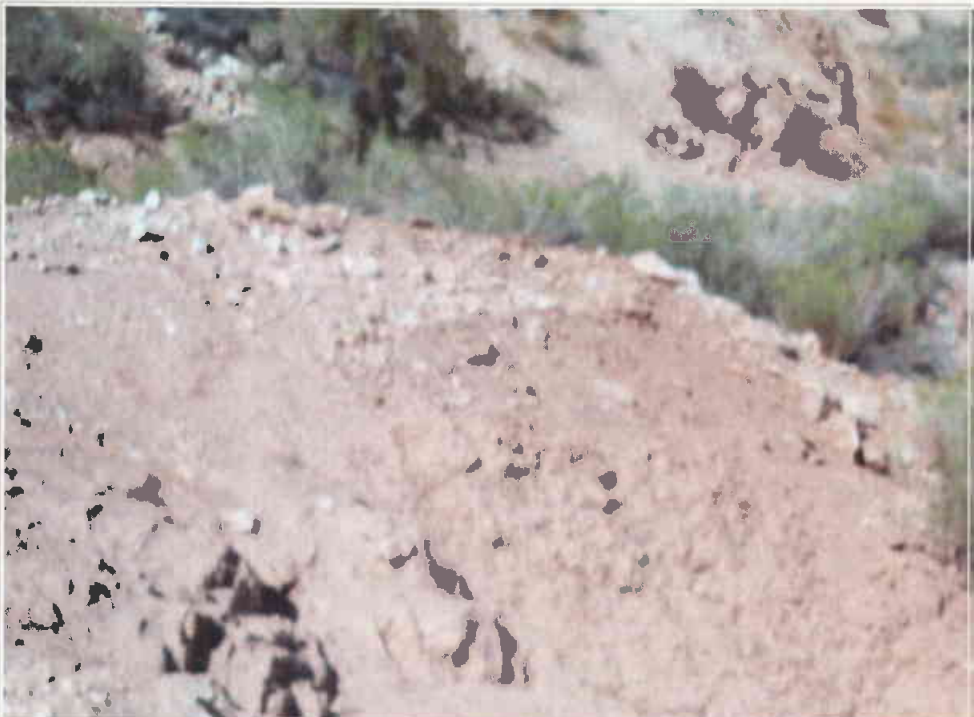
Slope that needs to be pushed down to minimize rills and gullies.

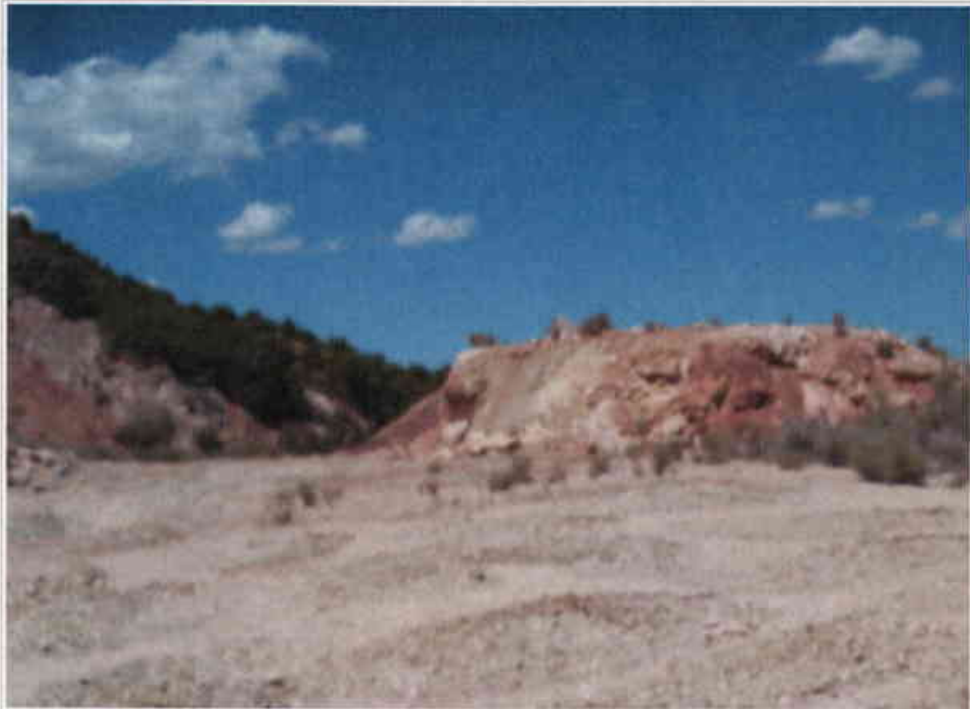
The seed bed preparation for the site was inadequate. The Operator should rip the pad areas in late November or early December and then seed the area. The pocks were not deep enough to promote vegetation establishment. The current seed bed preparation is inadequate. There are few if any plants growing in the pad area.

Pocks are too shallow to promote vegetation growth. The Operator should rip the area in the late fall and then seed.

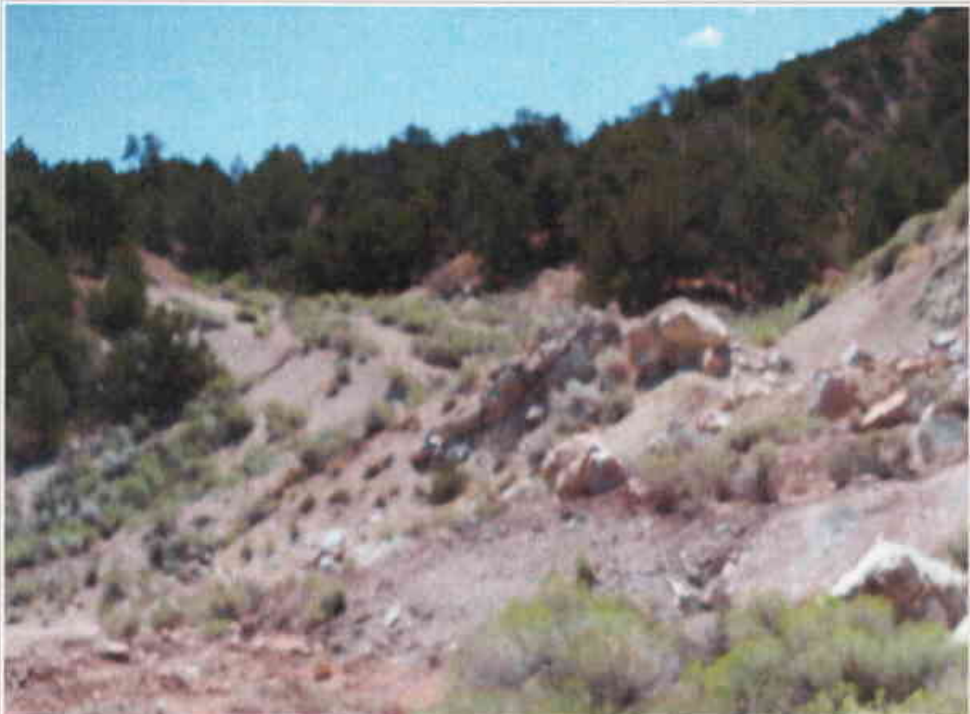
Lack of vegetation on disturbed area and vegetation on surrounding area suggests that seed bed preparation is essential for the establishment of vegetation.
